**Object: Preliminary survey at Roncovetro landslide (28 May 2014)**

On 28 May 2014 a preliminary field survey has been performed at Roncovetro landslide (RE) by technicians from RER, DST-UNIFI and INGV.

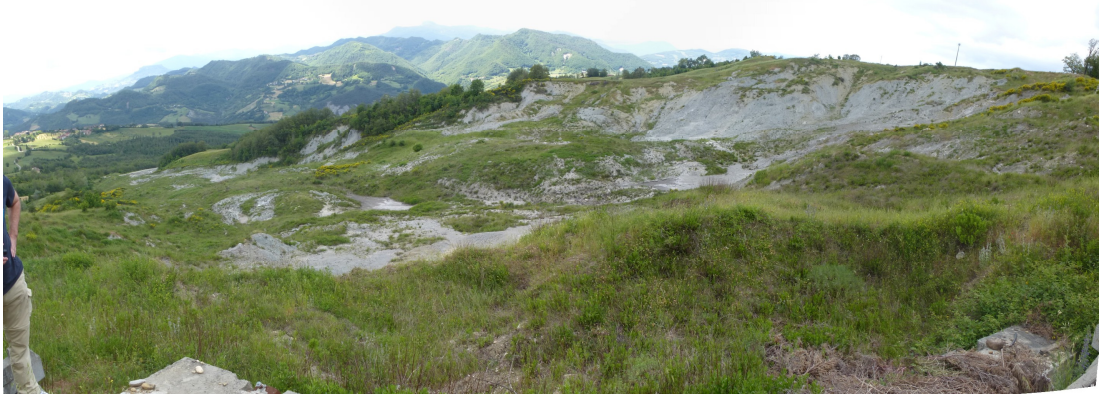
The absence of vegetation in certain zones are the results of continuous processes of deformation and erosion characterizing the more unstable areas, whose localization is important in order to individuate candidate areas for Wi-GIM monitoring (Figure 1).

**Figure 1. Photographic composition of the upper part of Roncovetro landslide.**

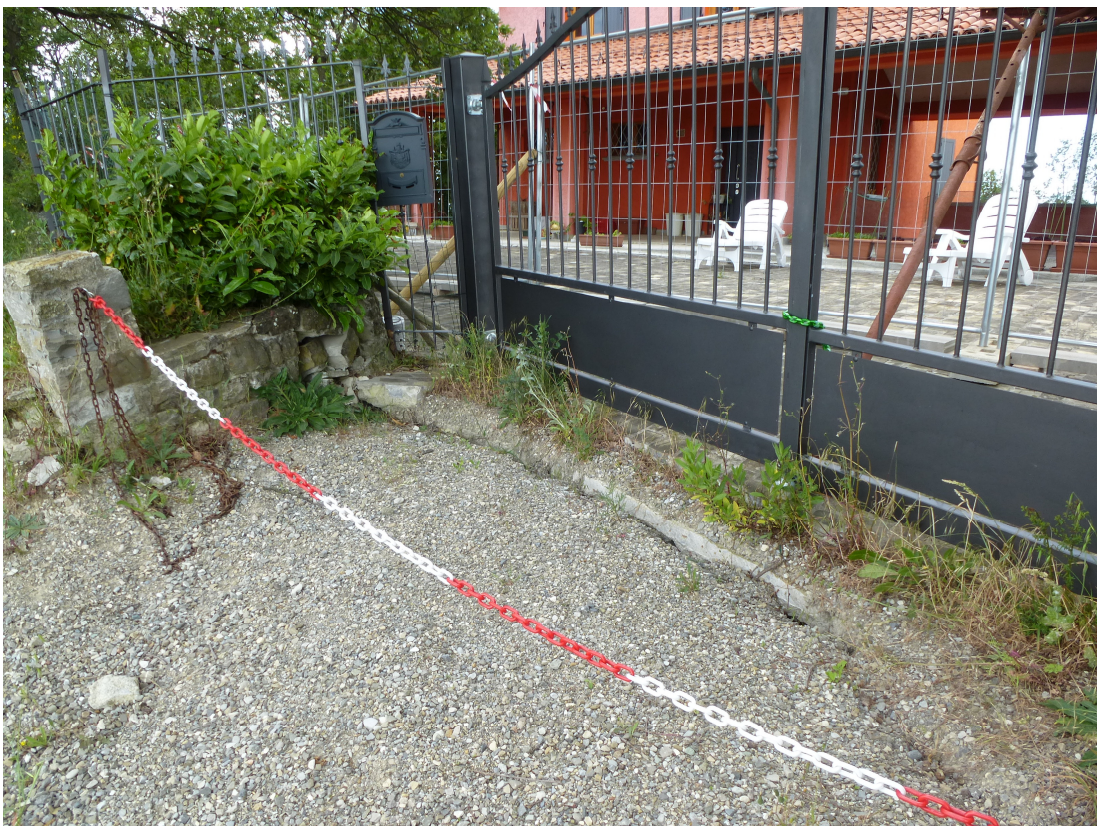
The survey showed that the deformation caused by the landslide produces severe damage also beyond the main body, to affect a neighbouring building (Figure 2). However, stable areas can be found even close to the fracture, and represent possible installation points for the total station.

**Figure 2. Damages on a neighbouring building.**

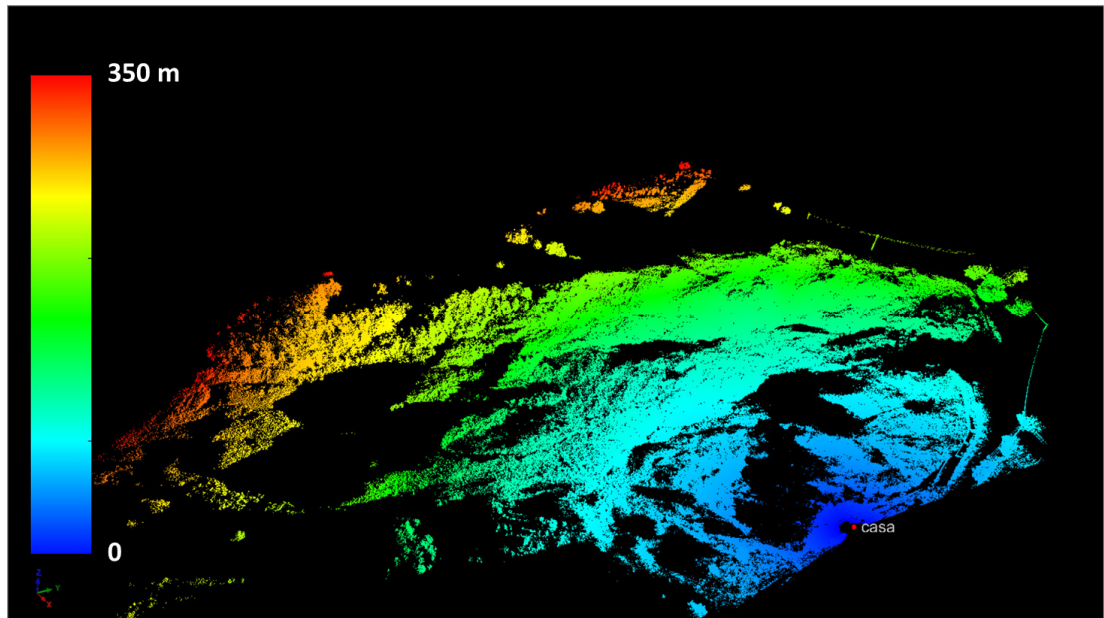
Eventually 4 reflectors were installed on the upper part of the landslide and a terrestrial laser scan has been acquired as a reference (Figure 3). The exact location of the reflectors has been recorded with a high precision GPS in order to allow the quantitative comparison between the reference scan and the future one. This will furnish a support for deciding the optimal installation points of the total station and Wi-GIM.

Figure 3. 3D Lidar model coloured by range.
